THE NEWEA

Are Your Open-Channel Meters Accurate? How a \$5,000 meter saved a city \$300,000

Jeff J. Cantwell
Flow Assessment Services, LLC

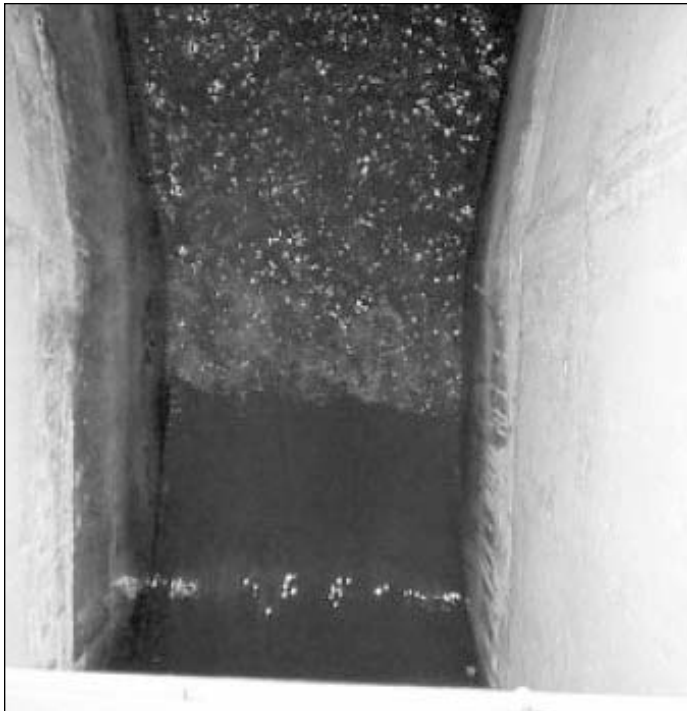
Figure 1. Flume throat

If the area-velocity meter was right, the flume had to be wrong. The team looked for clues that this may be the case. The first visual clue was the approach pattern to the throat of the flume (see figure 1). Flumes require that "The approaching flow should be well distributed across the channel, and relatively free of turbulent waves. Generally a site with high velocity of approach should not be selected [Isco Open Channel Flow Measurement Handbook, fifth edition, p. 65]." Standing waves, as seen in the approach of this flume, indicate either an improper approach velocity or flow in excess of the flume rating. This was enough to merit an investigation by Lowell's engineers and a third party flow expert.

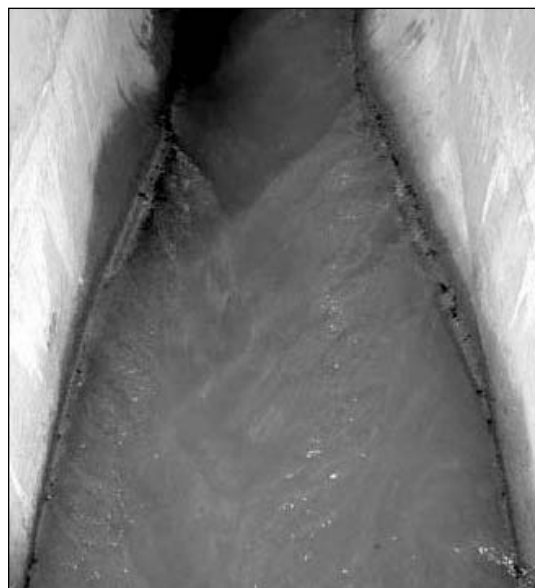
Figure 2. CDM picture of imbalanced approach velocity pattern

The plans for the original installation show the pipe entering the vault at an angle of 8 degrees 30 minutes with a slope of 0.00031. Measurements taken on August 9 indicate the angle is about 4 degrees, 43 minutes and the slope greater than 0.007. The invert of the pipe and the floor of a transition section before the flume are at the same elevation as the flume inlet section. The floor of the transition section is also very close to level."

CDM noted the measured slope was 20 times greater than the designed slope and the transition from the Tewksbury interceptor to the flume was skewed, causing an imbalance in the approach velocity pattern (Figure 2). The CDM report also noted the level transmitters being used at the flume were out of calibration. It verified that the specifications of the area-velocity meter matched this project's requirements and its settings were proper for this installation.

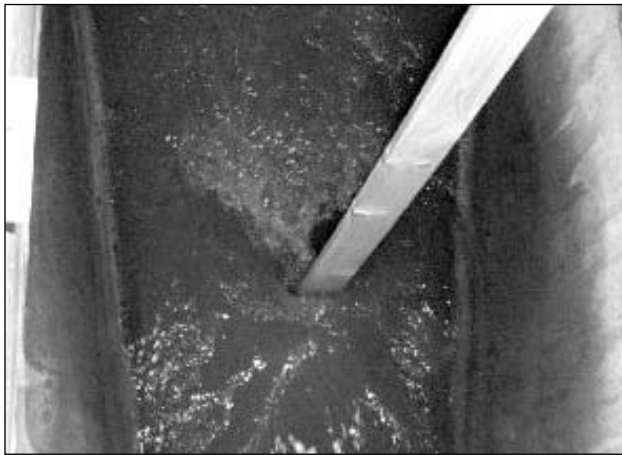
Figure 3. Maguire Group's temporary energy dissipater

To visually prove that the approach velocity was causing the inaccuracy, Maguire Group held a large wooden board in the upstream flow approach to dissipate the energy (see Figure 3). The results were a dramatic and almost instant increase of the flume flow reading to agree with the area-velocity meter.

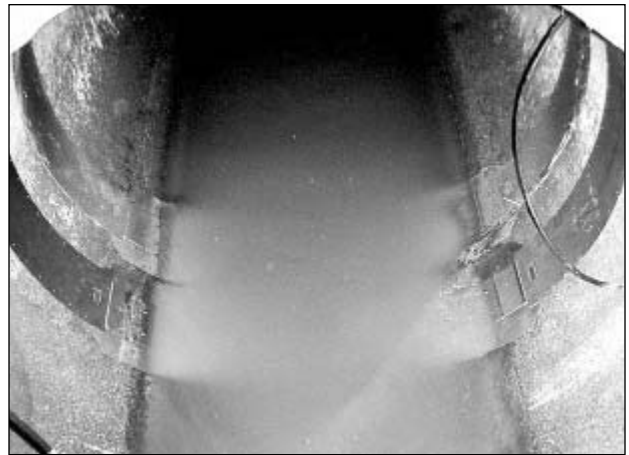
Figure 4. ISCO area-velocity meter probe

An independent third-party expert in flow measurement, Flow Assessment Services, reviewed the CDM and Maguire Group reports. FAS suggested installing a third meter to see if it would correlate with either of the first two meters. FAS selected, with the client's approval, the Isco area-velocity meter. After careful installation of the meter, and a thorough measurement of the pipe I.D., the readings of the temporary area-velocity meter matched the existing area-velocity meter. The temporary check meter was left in place for 60 days, and the readings were posted on an Internet site for the convenience of all parties. The results were conclusive: the two area-velocity meters agreed, and the existing flume agreed with these readings when the upstream velocity problems were addressed.

The project team thus set out to increase the accuracy of the existing flume, and eventually supplemented the area-velocity meter with a redundant ultrasonic meter. Two independent level measurements tracked well, giving the team assurance in those readings. The velocity readings provide good diagnostics, so both sides of the $Q=V \cdot A$ basic flow equation were satisfied with reliable readings. Unlike the flume, the area-velocity meter provided a wider range of flow measurement from low flow through surcharge conditions. ■
